VALVE TAPPET ADJUSTMENT

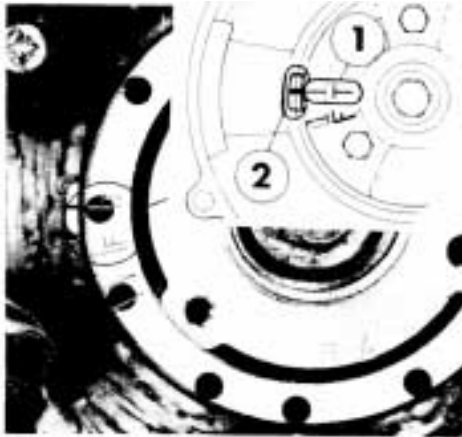
- ① "T" mark
- ② Index mark

Valve tappet clearance must be checked with the engine cold.

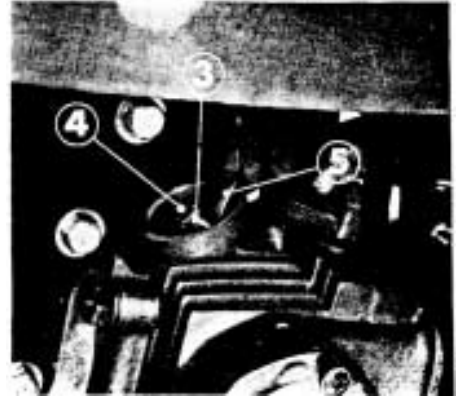
- ③ Adjusting screw lock nut
- ④ Adjusting screw
- ⑤ Tappet gauge

Valve tappet clearance should be maintained at 0.002 in. (0.05mm). Excessive clearance will cause tappet noise. Insufficient clearance will cause loss of power and valve damage.
