● Valve Tappet Clearance Adjustment

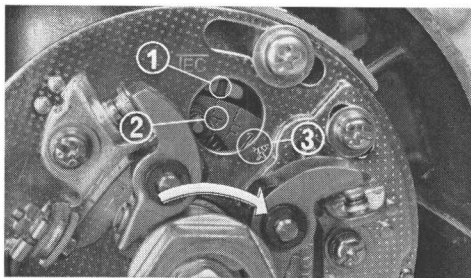
- (1) The cylinders are numbered 1-4 starting from the left side when facing

- ① Index mark
- ② "T" mark
- ③ 1-4 cylinder mark

forward while sitting on the motor-cycle.

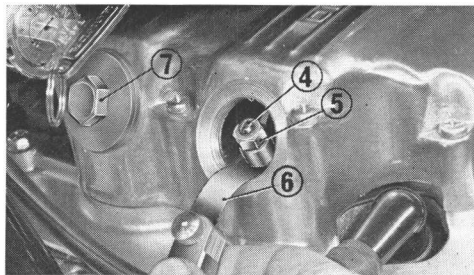
- (2) The check or adjustment of the tappet clearance should be performed while the engine is cold. The clearance may tend to increase as the temperature rises.
- a. Turn fuel valve to the "OFF" position, remove both fuel lines from the fuel valve body, raise the seat and pull the rear fuel tank rubber mounting away from the rear tank mount. Raise the

- ④ Tappet adjusting screw
- ⑤ Lock nut
- ⑥ Feeler gauge
- ⑦ Hole cap

Excessive valve clearance will cause tappet noise, and insufficient clearance will cause valve damage and low power. Therefore, the valve tappet clearance should be maintained properly. Perform the valve tappet clearance check at the specified intervals.
