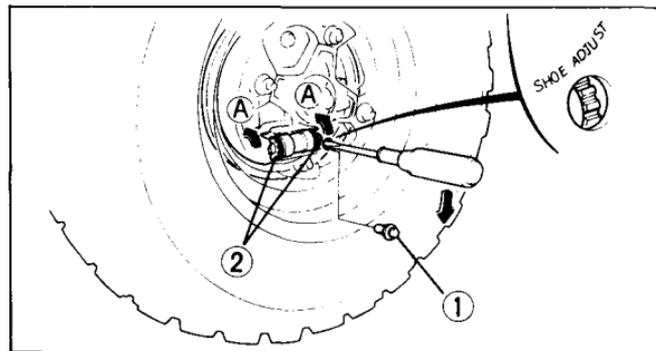
1. Pump the brake lever 2-3 times firmly and release it.
2. Remove the adjusting hole cap (1).
3. Turn the both brake shoe adjusters (2) up with a screwdriver until the front brake locks.

- (1) Adjustment hole cap    (2) Adjusters  
(A) Brake locks

4. Back the adjusters off three clicks and pump the brake lever several times.
5. Turn the wheel manually and make sure it does not drag.
6. Adjust the other front brake.
7. Install the rubber cap.
