Master Link, Drive Chain, and Sprocket Replacement :

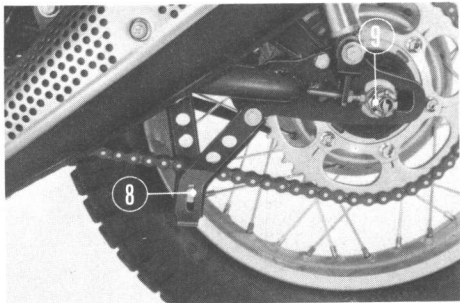
⑧ Rear axle

NOTE : If correct drive chain adjustment requires the rear axle to be moved to the position V, then the drive chain is excessively worn and should be replaced.
