Drive Chain

Drive Chain Slack Inspection

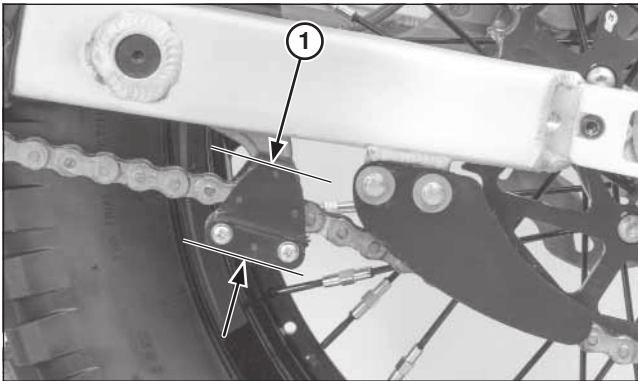
(1) DRIVE CHAIN SLACK

Measure chain slack at the lower section midway between the sprockets.

Drive chain slack: 25 – 35 mm (1.0 – 1.4 in)

Rotate the wheel and chain slack in several sections. If slack in one section increases beyond the standard measurement, this indicates the chain has stretched and needs to be replaced.
