## ► Checking the Drive Chain Wear

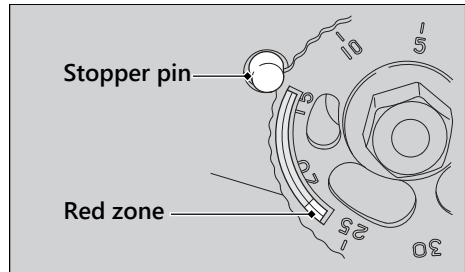
Check the chain wear label when adjusting the drive chain. If the stopper pin on the swingarm enters the red zone on the label after the chain has been adjusted to the proper slack, the chain is excessively worn and must be replaced.
