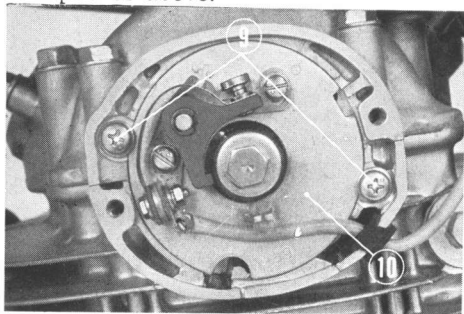
2. If ignition timing is incorrect loosen the two base plate locking screws ⑨ and turn the base plate ⑩ slowly in either direction. Turning it clockwise will advance timing, and vice versa. Use of a stroboscopic timing light is recommended to obtain accurate setting. After adjustment, make sure that the "F" mark is aligned with index mark at an idle speed of 1,200 rpm, and also that index mark stays within advance marks ⑧ (page 39) at 4,000 rpm. or above.

⑨ Base plate locking screws ⑩ Base plate

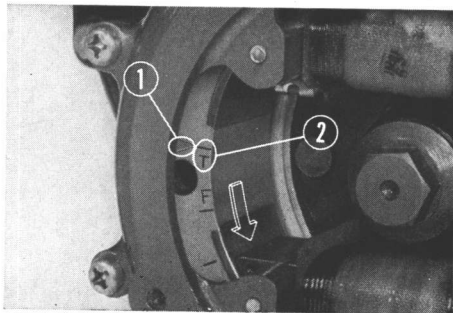
1. Raise the seat and remove the fuel tank.
2. Remove the intake and exhaust tappet covers.
3. Remove the generator cover.

① Index mark ② "T" mark
