Chapter lights / instruments / switches (ED/2ED)

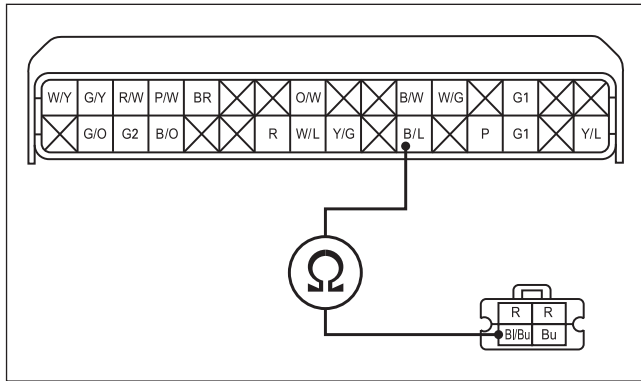
Wire harness inspection

Check for continuity of the Black/Blue wire between the fan motor relay 2P (Natural) connector and ECM 32P (Black) connector. There should be continuity. If there is no continuity, repair or replace the wire harness.
