CRANKCASE/CRANKSHAFT/TRANSMISSION

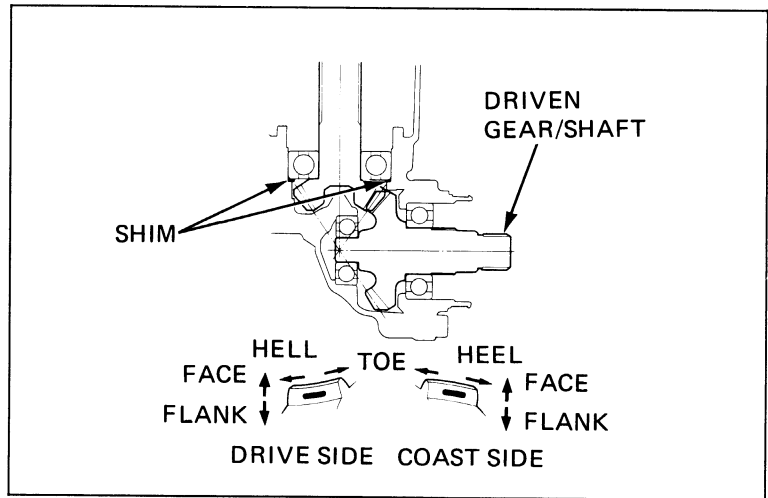
Contact is normal if Prussian Blue is transferred to the approximate center of each tooth and slightly to the side.

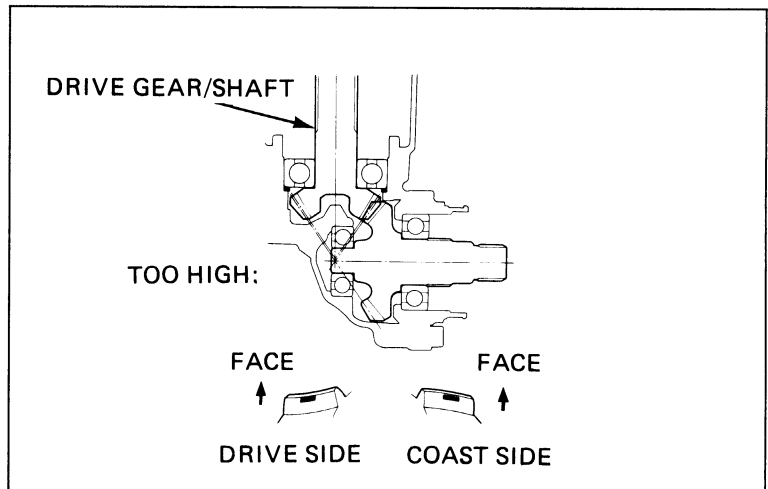
If the pattern is not correct, remove and replace the drive gear adjustment shim.

Replace the shim with a thinner one if the contact pattern is too high.

The pattern will shift about 1.0 mm (0.04 in) when the thickness of the shim is changed by 0.10 mm (0.04 in).

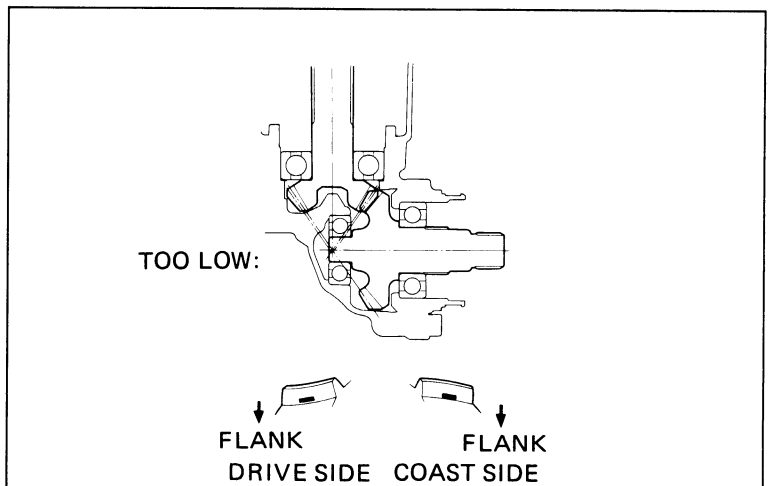
Replace the drive gear adjustment shim with a thicker one if the contact is too low.
