CRANKSHAFT

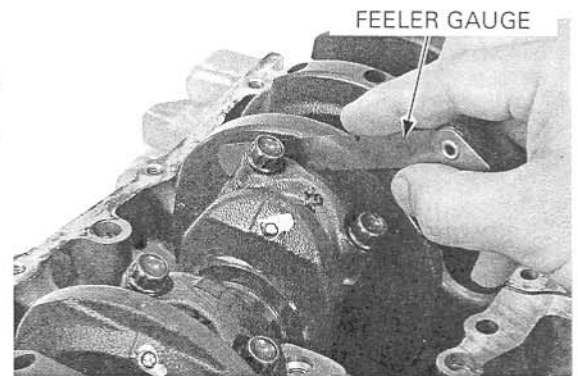
SIDE CLEARANCE INSPECTION

Measure the connecting rod side clearance.

SERVICE LIMIT: 0.35 mm (0.014 in)

If the clearance exceeds the service limit, replace the connecting rod.

Recheck and if still out of limit, replace the crankshaft.

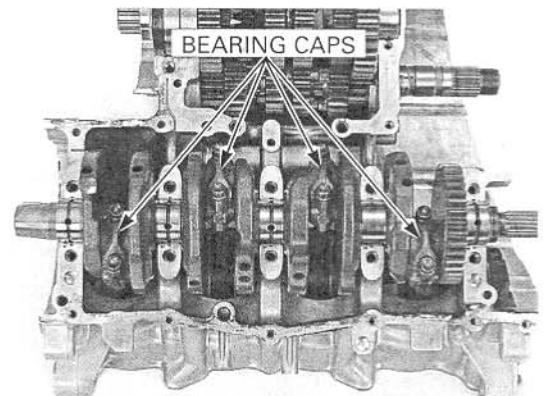
REMOVAL

Before removal, position all the pistons at TDC (Top Dead Center) to prevent damaging the crankpin with the connecting rod.

Mark the bearing caps and bearings as you remove them to indicate the correct cylinder for reassembly.

Remove the connecting rod bearing cap bolts and bearing caps.

Tap the side of the cap lightly if the bearing cap is hard to remove.

Remove the crankshaft.

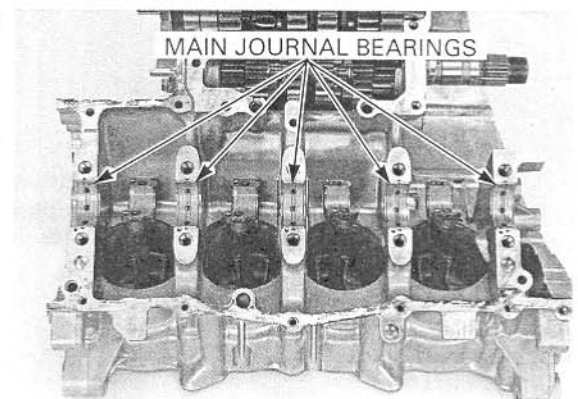
Remove the main journal bearings from both the crankcase halves.
