Valve Seat Refacing

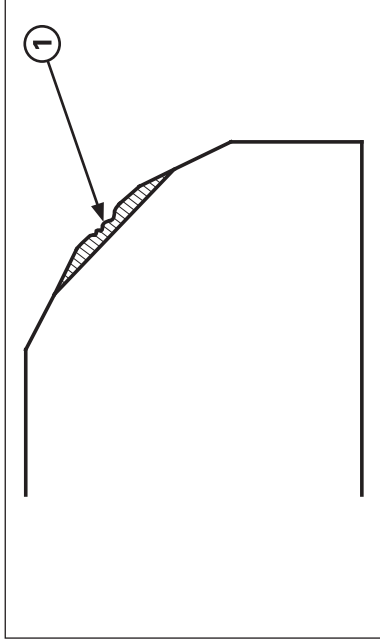
(1) ROUGHNESS

- Contact area (too high or too low)
– Reface the valve seat.

The valves cannot be ground, If a valve face is burned or badly worn or if it contacts the seat unevenly, replace the valve.

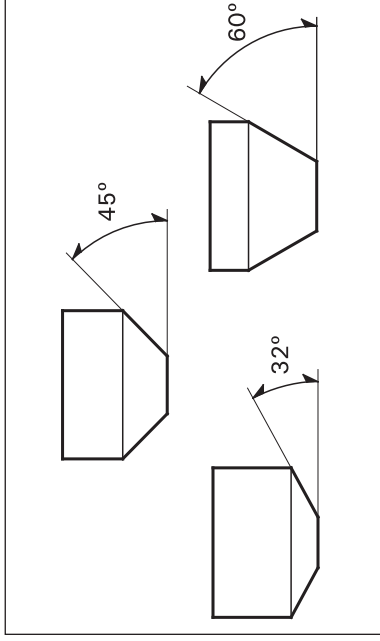
Valve seat cutters, grinders or equivalent valve seat refacing equipment are recommended to correct worn valve seat.
Follow the refacing manufacturer's instructions.

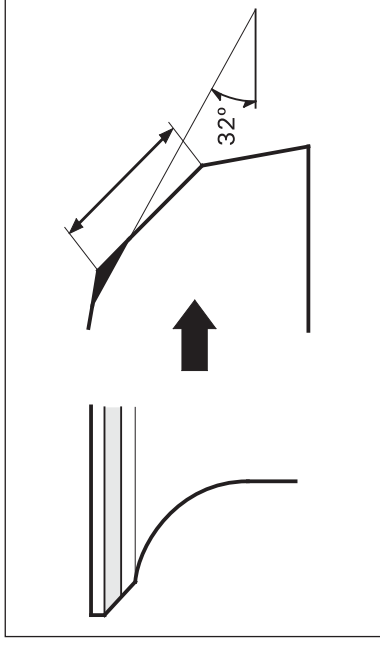
If the contact area is too high on the valve, the seat must be lowered using a 32° flat cutter.

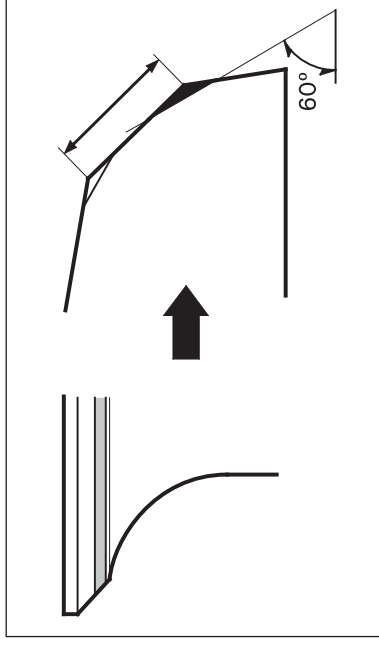
If the contact area is too lower on the valve, the seat must be raised using a 60° interior cutter.
